<p>回路追加</p>

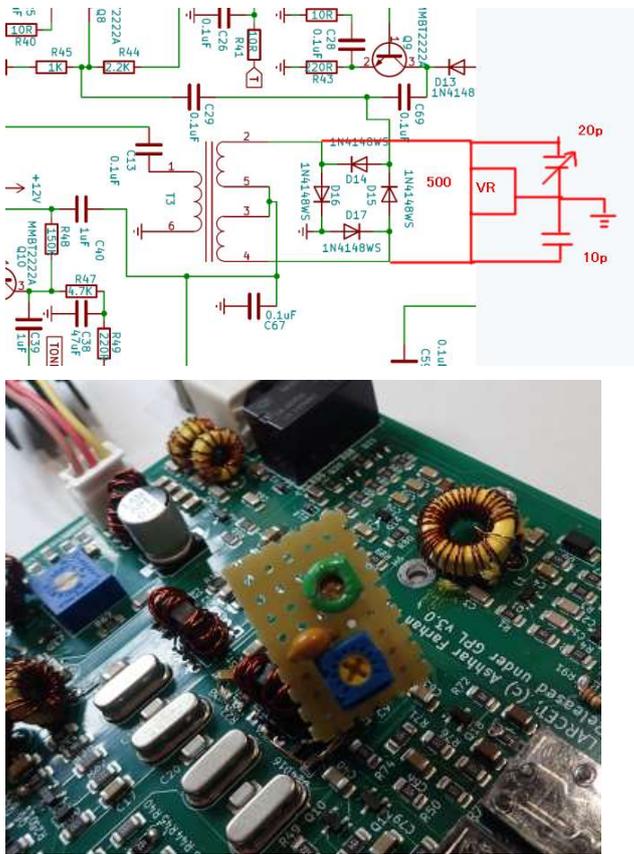
<p>The top part of the image shows a detailed circuit diagram for a mixer circuit. It features an IMB122224 IC, several resistors (R40, R41, R42, R43, R44, R45, R46, R47, R48, R49, R50), capacitors (C28, C29, C38, C39, C40, C67, C69), and a transformer T3. The transformer has primary terminals 1, 2, 3, 4, 5, 6 and secondary terminals 1, 2, 3, 4, 5. A variable capacitor VR is connected to the secondary terminals. The bottom part of the image is a photograph of the physical PCB, showing the components and transformer T3 in place.</p>
<p>スペアナ SSB 無変調送信</p>

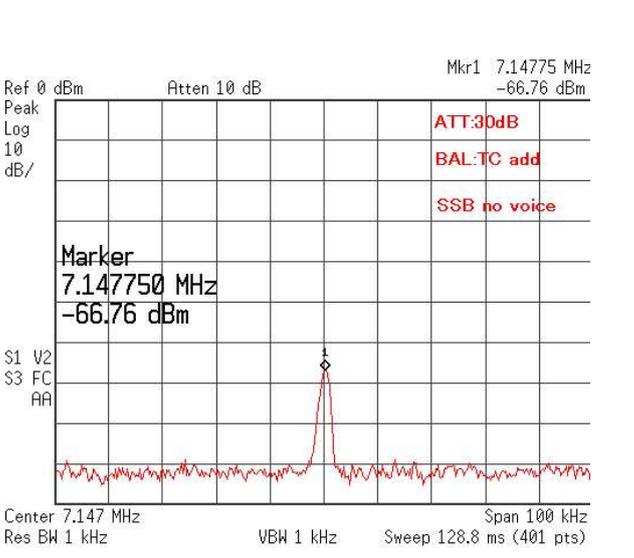
<p>The screenshot shows a spectrum analyzer display with the following parameters:</p> <ul style="list-style-type: none"> Ref 0 dBm Atten 10 dB Mkr1 7.14775 MHz Peak -66.76 dBm Log 10 dB/ ATT:30dB BAL:TC add SSB no voice Marker 7.147750 MHz -66.76 dBm S1 V2 S3 FC RA Center 7.147 MHz Res BW 1 kHz VBW 1 kHz Sweep 128.8 ms (401 pts) Span 100 kHz

local 入力に
3dB ATT 追加

Ref -10 dBm	Atten 5 dB	Mkr1 7.149800 MHz
Peak		-71.55 dBm
Log		ATT:30dB
10		local 3dB ATT
dB/		SSB no voice
Marker		
7.149800 MHz		
-71.55 dBm		
V1 S2		
S3 FC		
AA		
Center 7.15 MHz		Span 10 kHz
Res BW 100 Hz	VBW 100 Hz	Sweep 605 ms (401 pts)

3dB 改善

ATT 追加

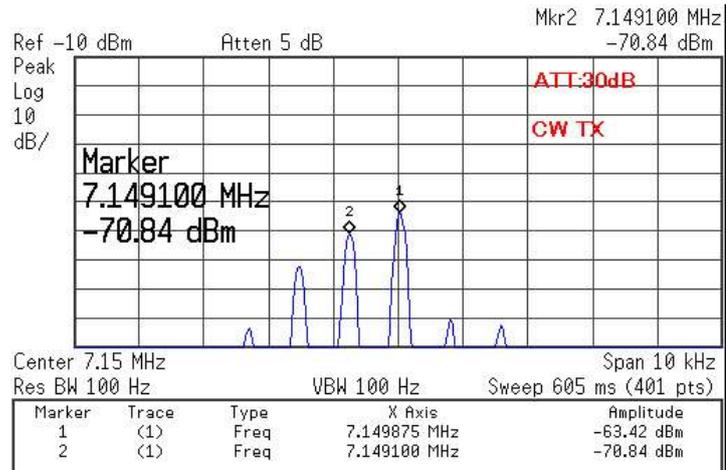
スペアナ
CW 送信

820Hz 送信 キャリアより 7dB up

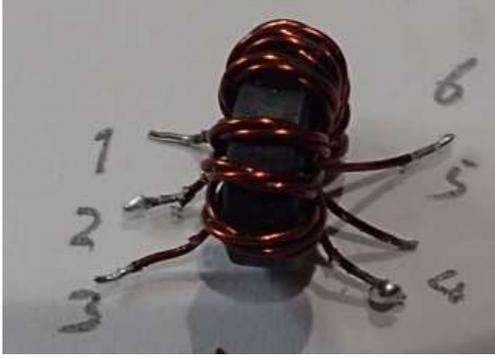
T3取り外し

T3を含むMIXER動作がおかしいと思われましたので、T3を取り外してみました。

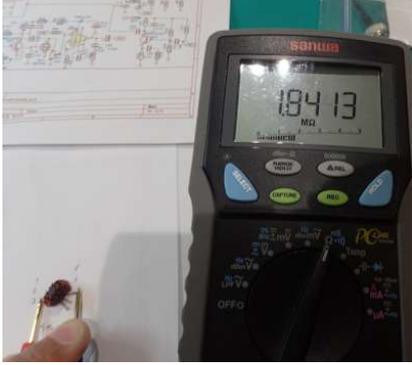
1-6間：0 Ω
端子間抵抗確認

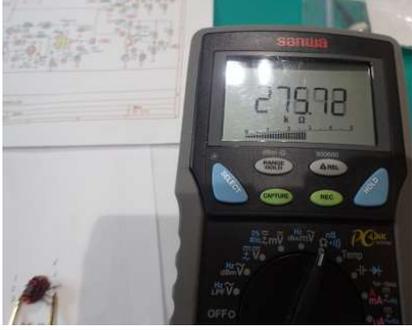
3-6間：1.84MΩ

3-5間：275kΩ
不思議な抵抗値になりました。10回を解いたところ、マグネットワイヤー自体に上記抵抗が存在しました。

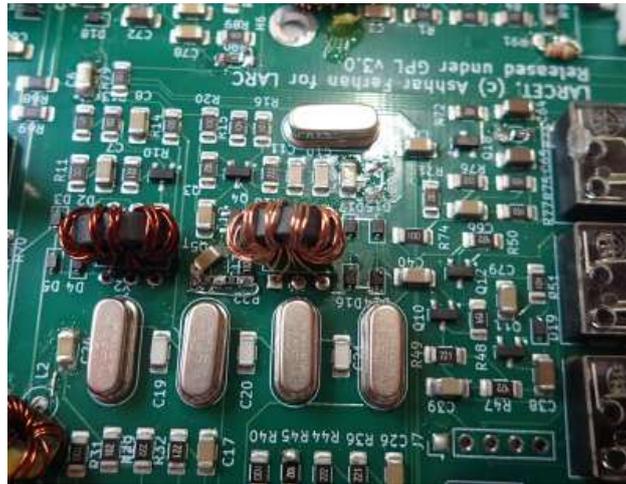
まき直し

日本製
ポリウレタン
10回巻き

抵抗測定 OK でした。

1-6 間 : 0 Ω

3-6 間 : 無限大

3-5 間 : 無限大

保険で、T1,T 2 もまき直した方が良さそうです。

まだ未実施

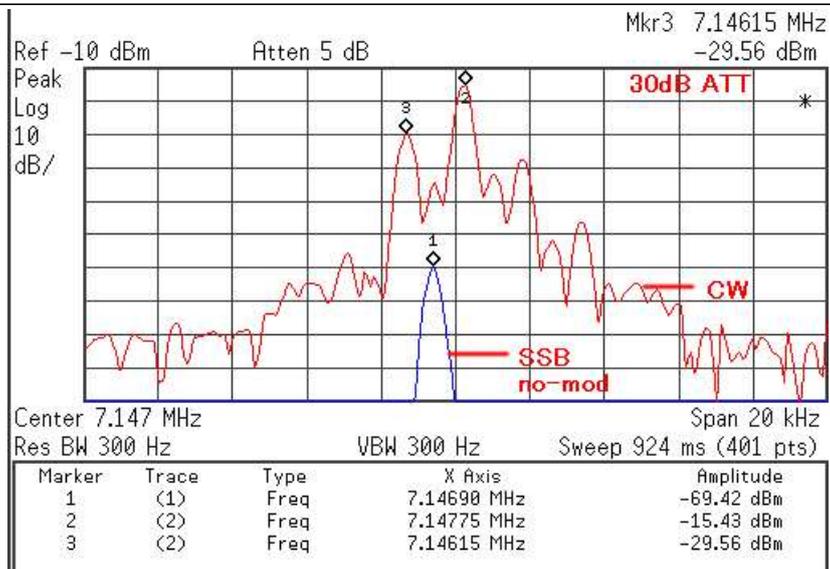
とりあえず
送信スペアナ

SSB 無変調時のキャリア漏れ : $-69.42+30=-39.42\text{dBm}$

CW 時 キャリア漏れ : $-29.56+30=0.44\text{dBm}$

820Hz トーン : $-15.43+30=14.57\text{dBm}$

これから、T1,T2 をまき直します。
